BERGER FOUNTAIN MECHANICAL ROOM

Loring Park, Minneapolis

Dunwoody College of Technology

Studio 5

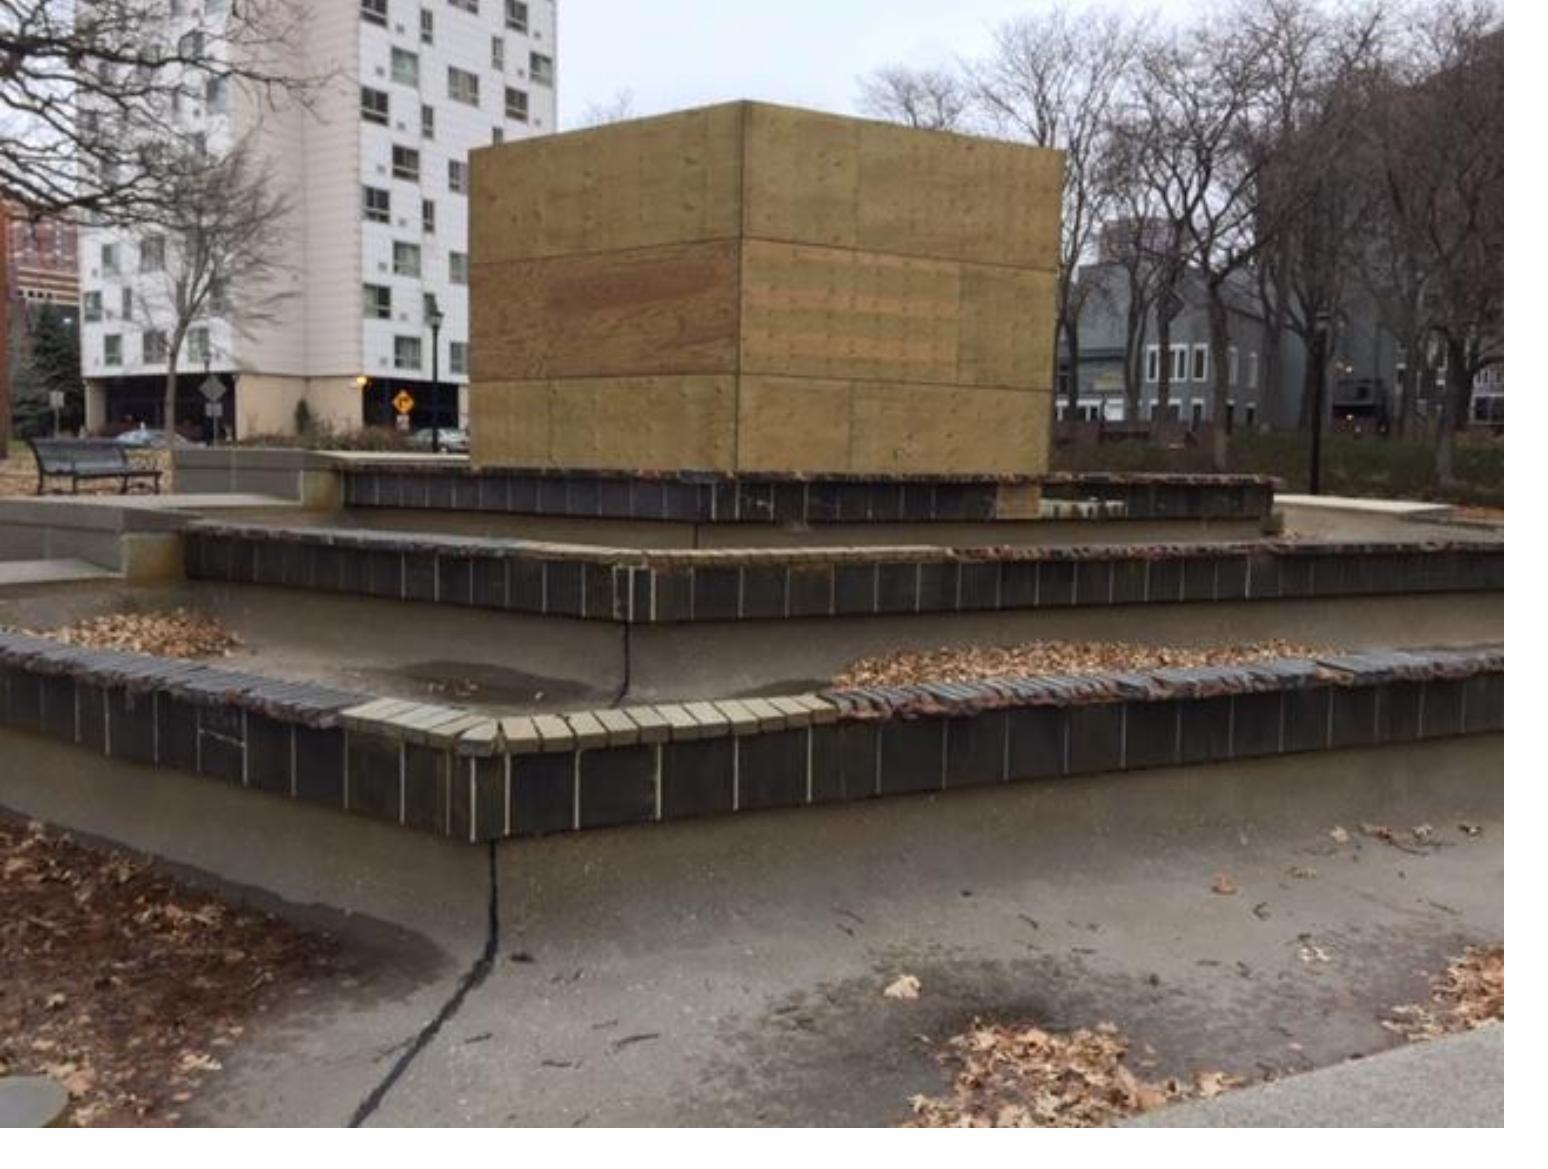
Fountain podium has severe leakage, bricks breaking, electrical failing and dangerous. Plywood enclosure has not experienced break-in or graffiti; occasionally stones are tossed by passerbys over the top and damage the light fixtures inside.

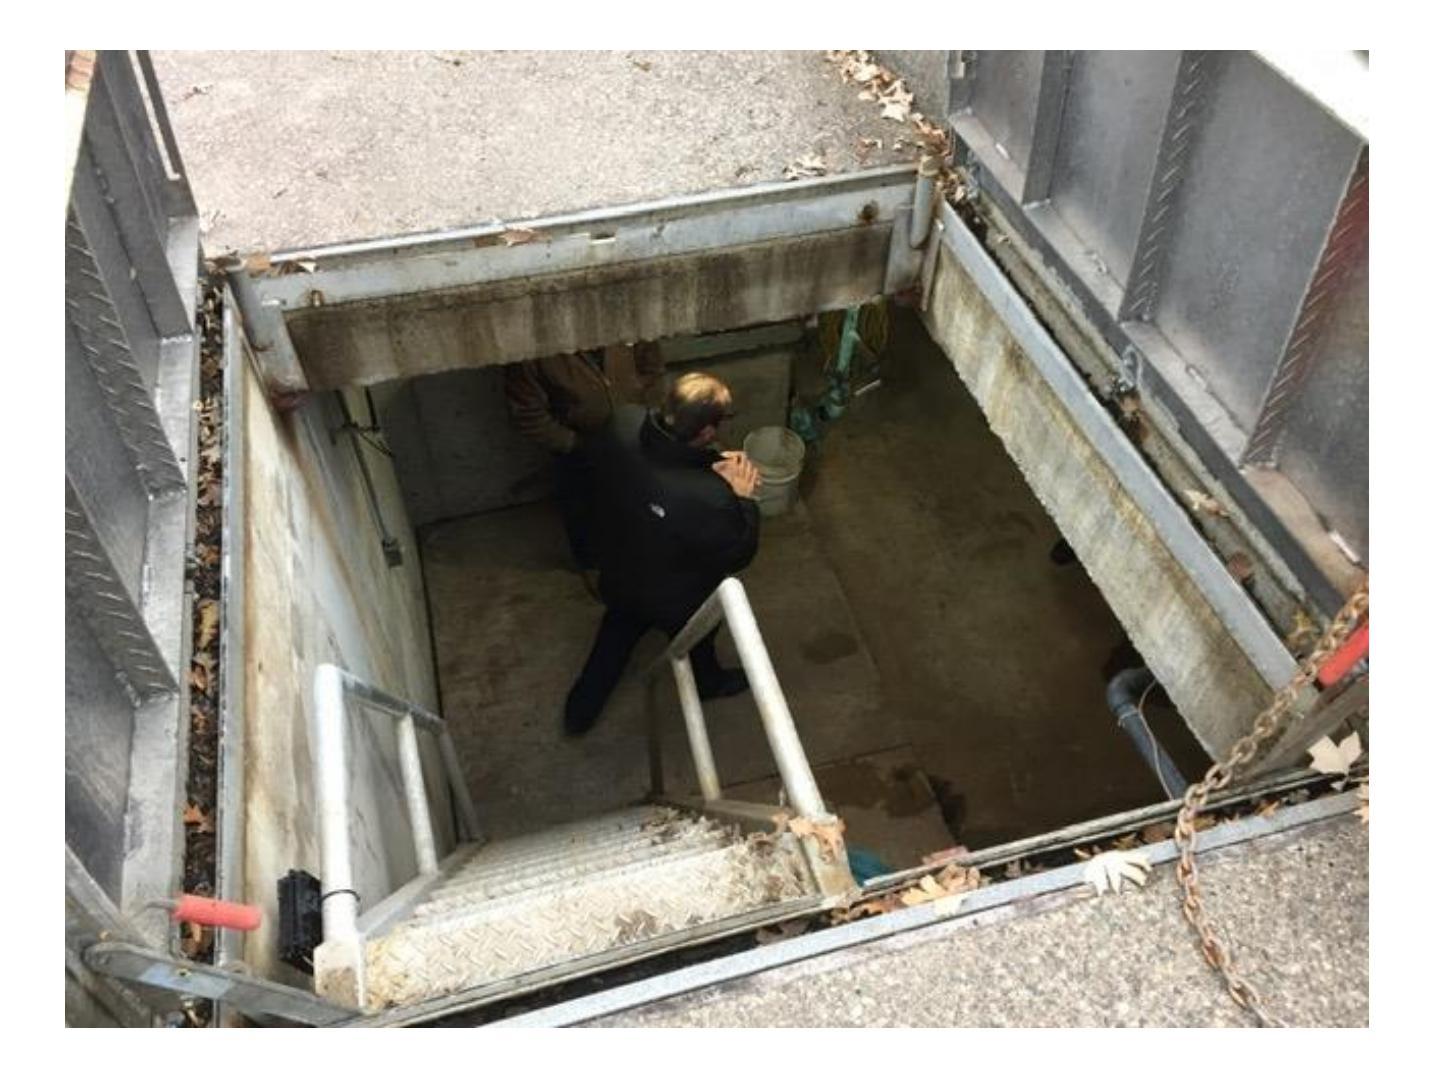
Metal trap door is located next to fountain podium Needs replacement

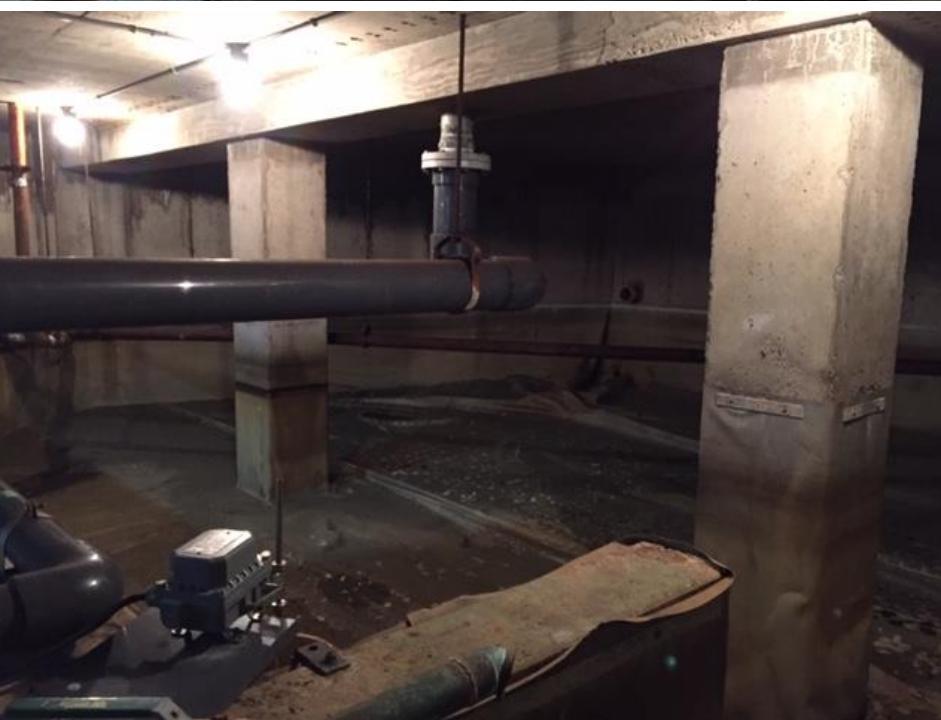
Mechanical Room under fountain.

Fountain stem above

Structural sound to carry weight: 53.5 tons of water; plywood enclosure = 1.2 tons

36-inch reservoir holds recycled water

Fountain basis above leaks "like a shower" below

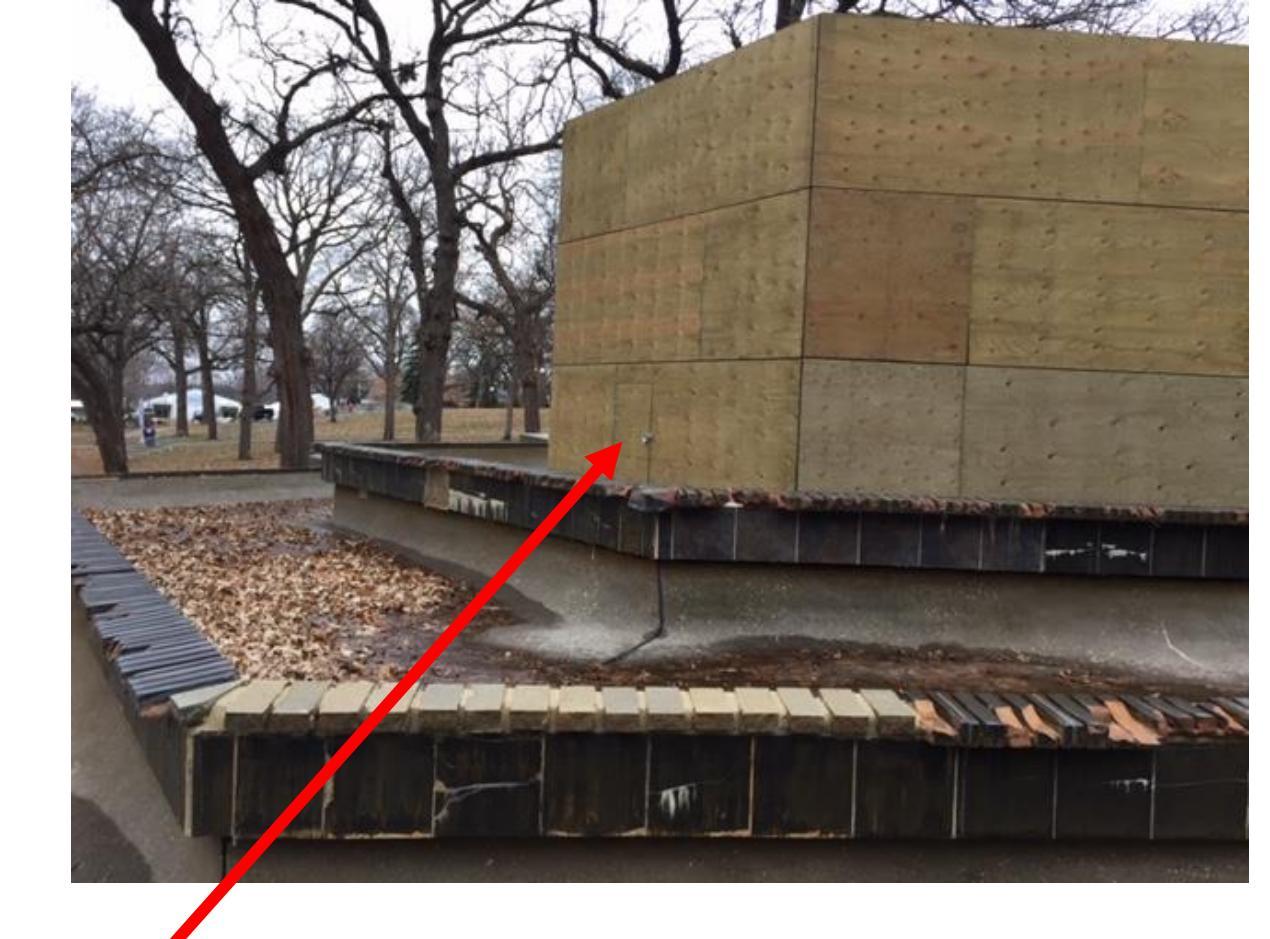
Access door 20" x 36"

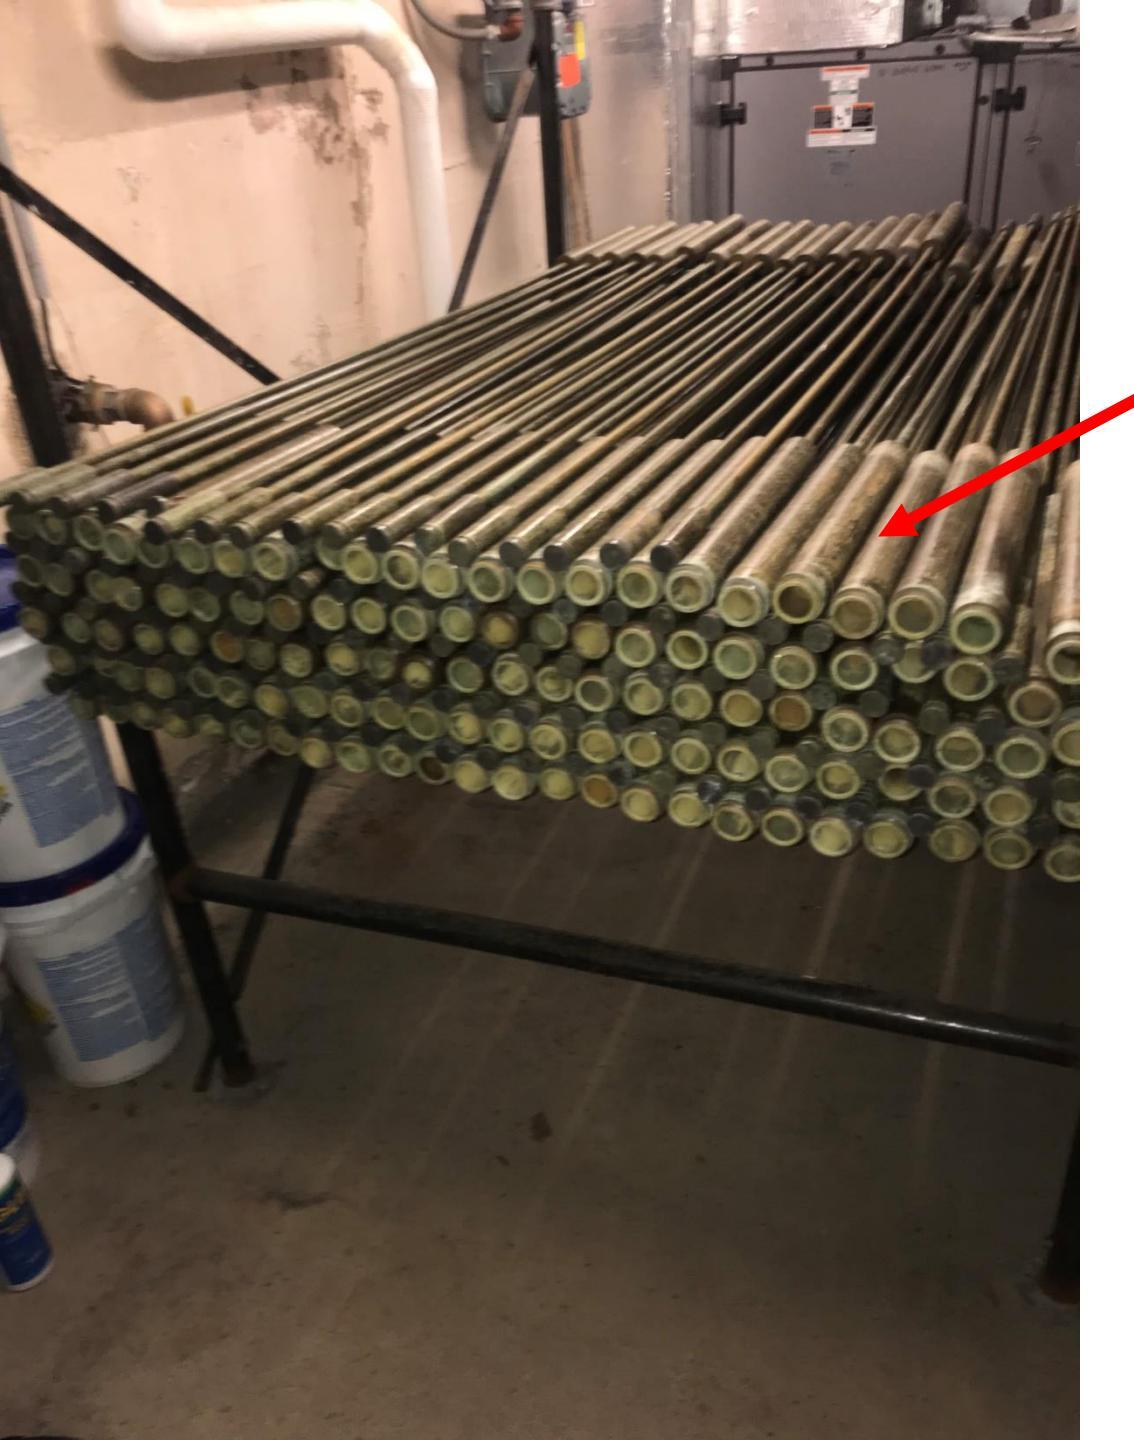
253 "stems" require cleaning to ensure proper fountain spray

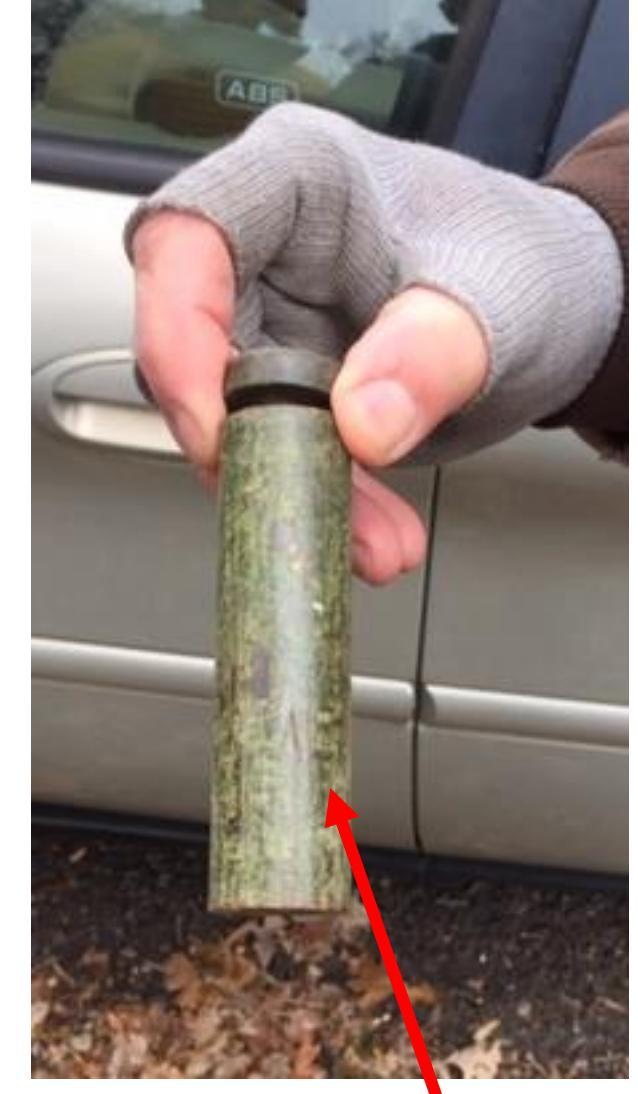
Spray nozzle is inserted into stem head

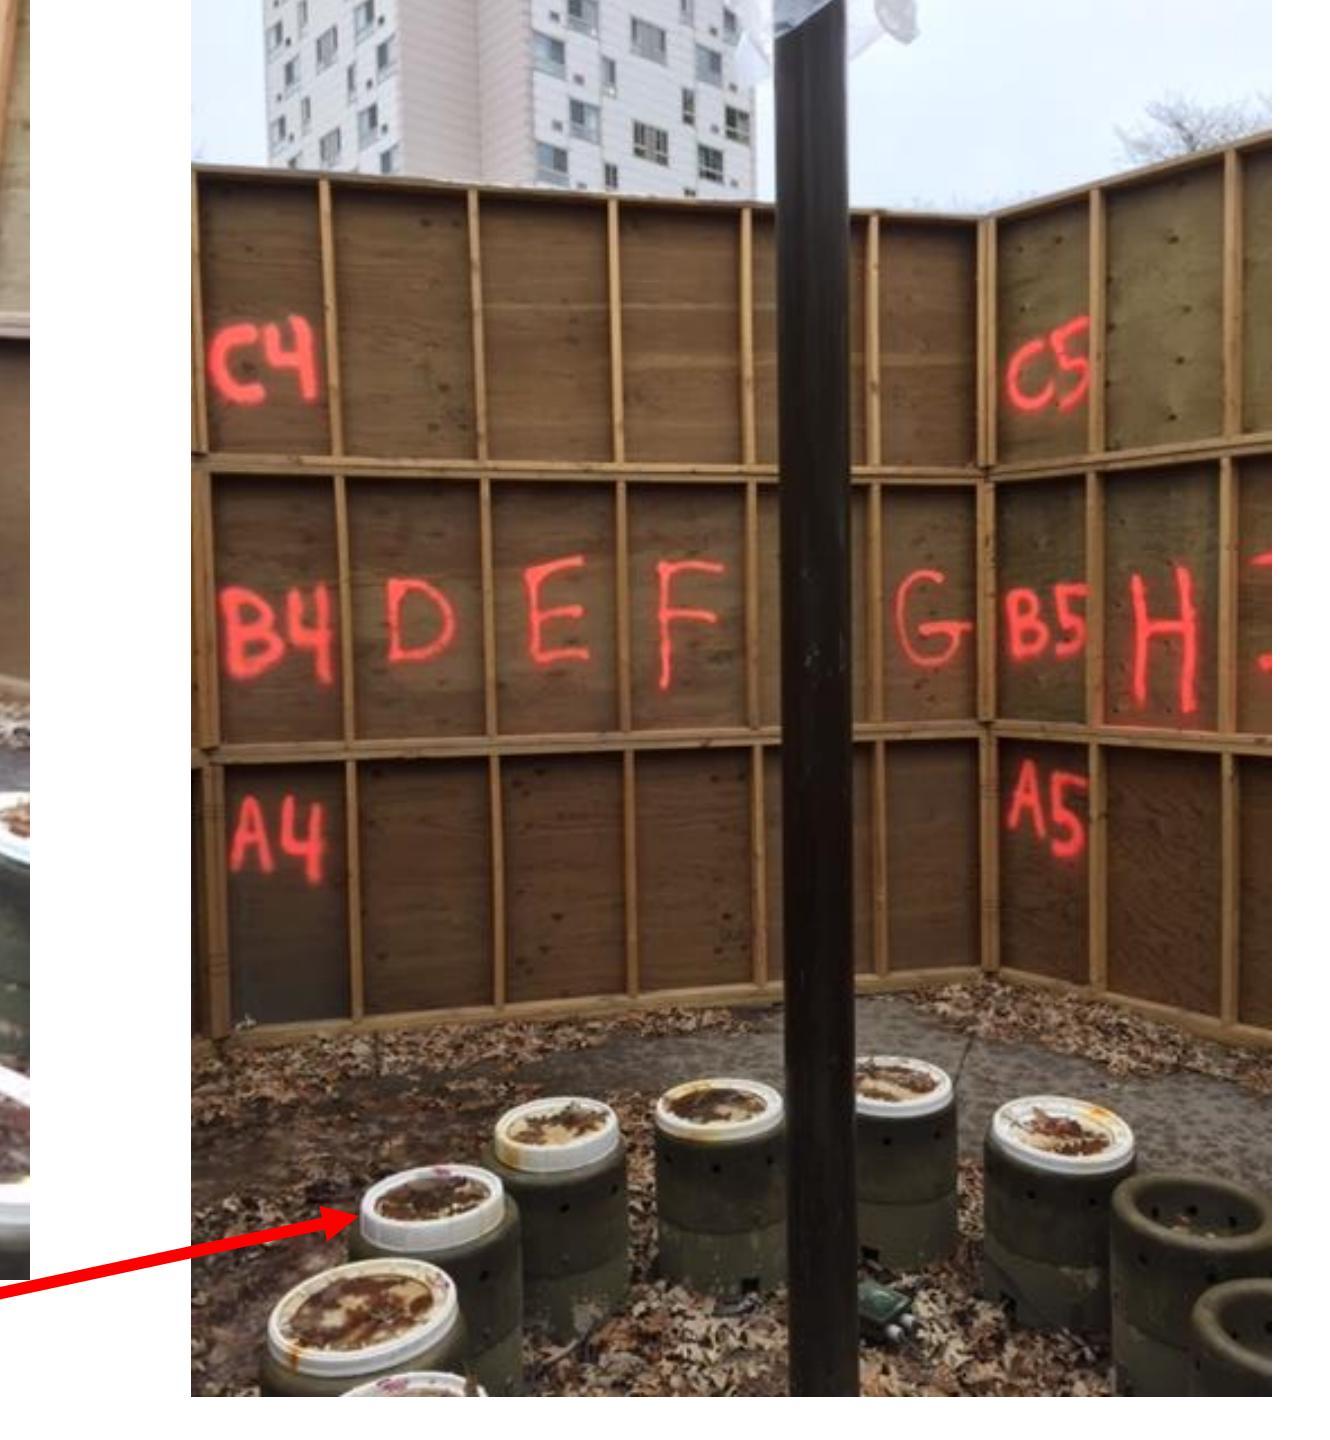
Underwater light fixtures

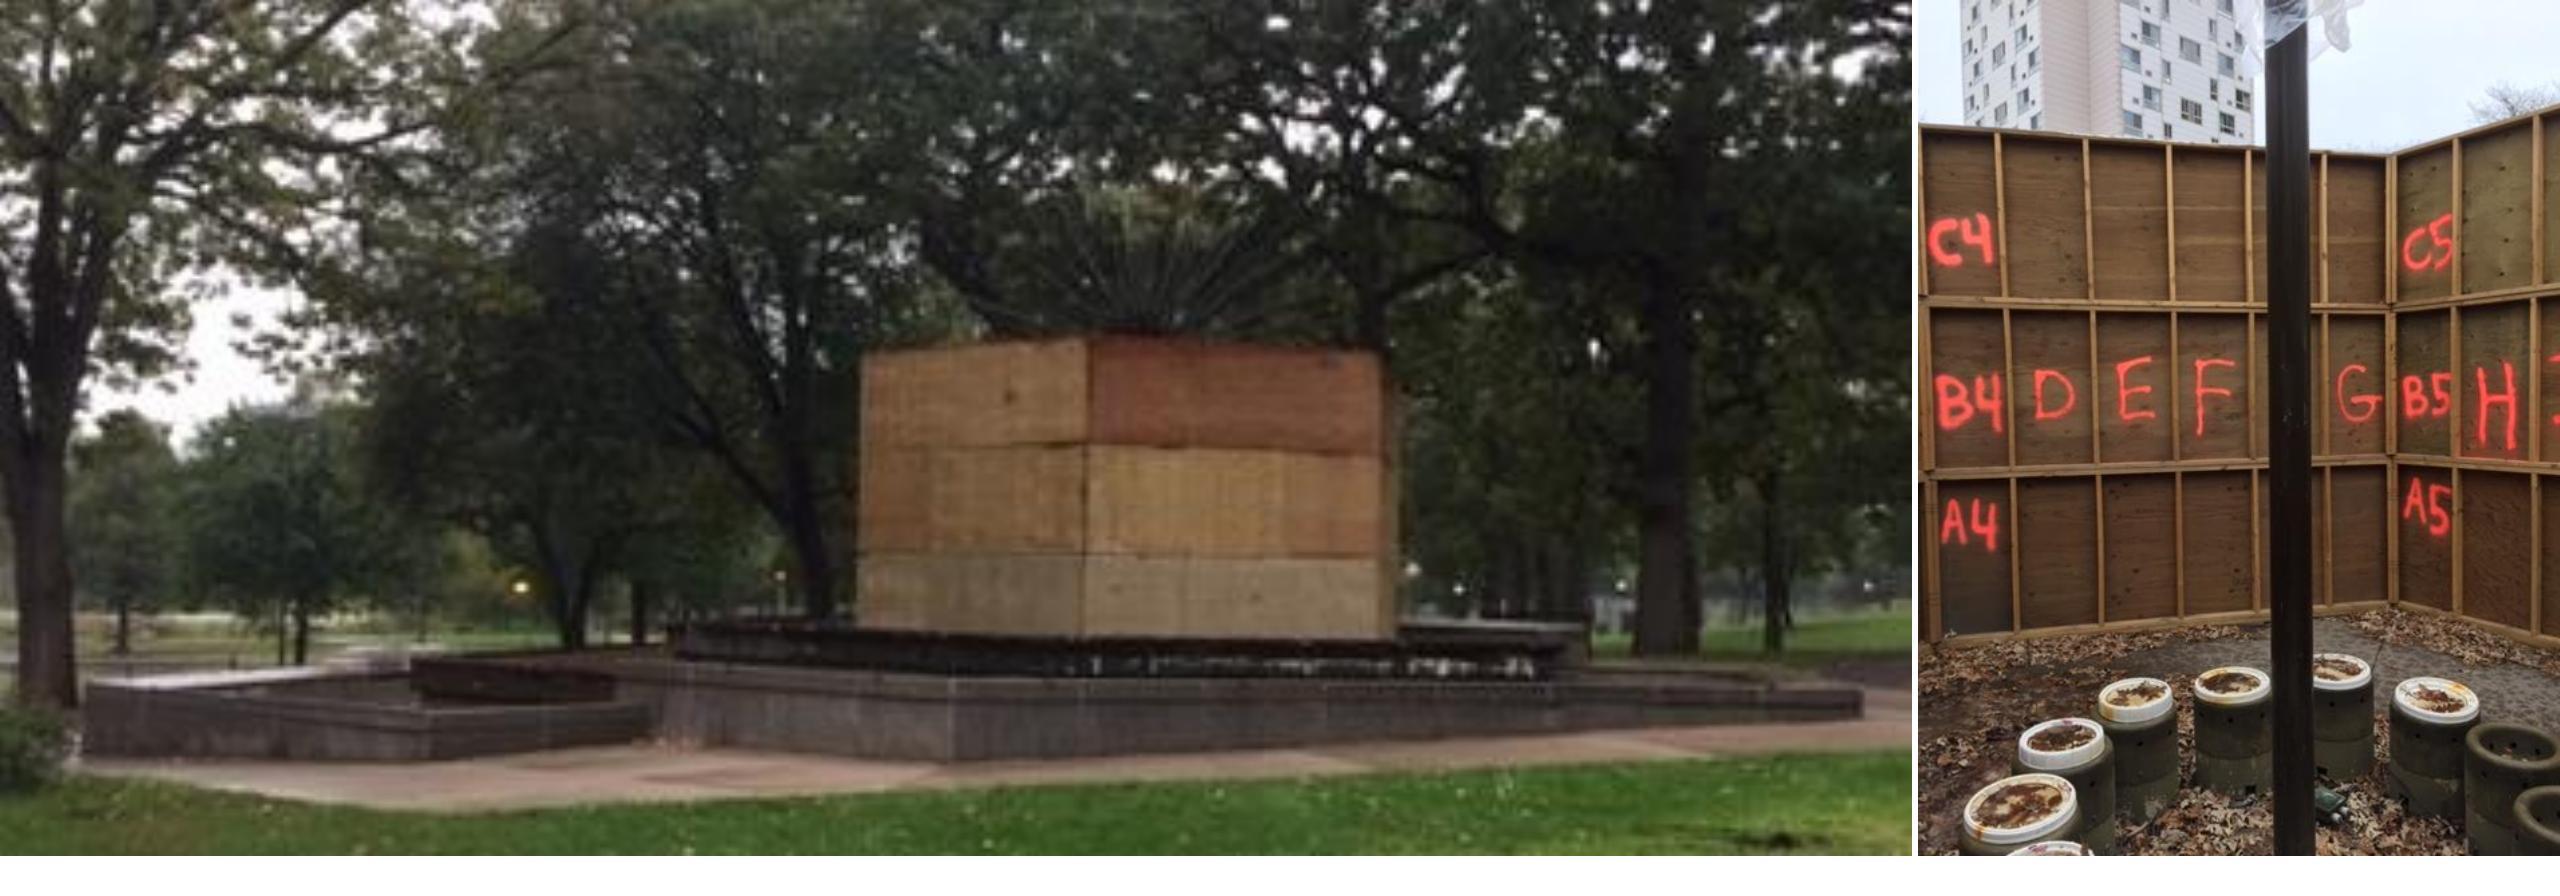
Plywood enclosure is installed prior to removing fountain "arms"; since it takes two – three days to remove the "arms".

NOTE: Plywood enclosure used to extend 4-feet taller to hide fountain.

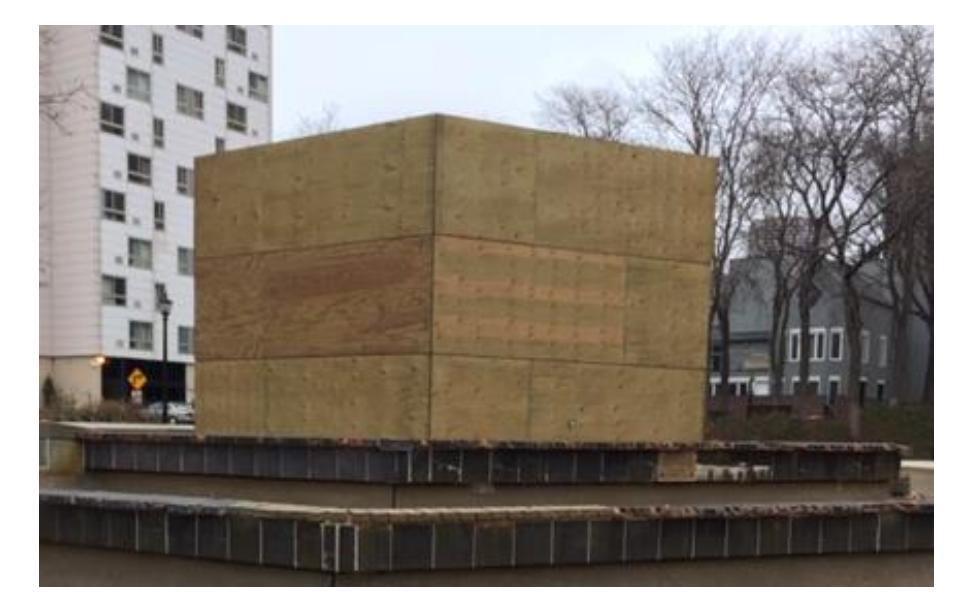
PLYWOOD ENCLSOURE:

Size: 20-feet wide x 15-feet tall

Weight: 30 sheets 4x8 1/2" CDX = 960 sqft = \$900 = 1,218 lbs 840 lineal feet of 2x4 = \$245 = 1,075 lbs 75 bolts = 15 lbs

Total Enclosure = 2,308 lbs or **1.15 tons** Water = 12,818 gallons top podium Water weight = 106,906 lbs = **53.5 tons**

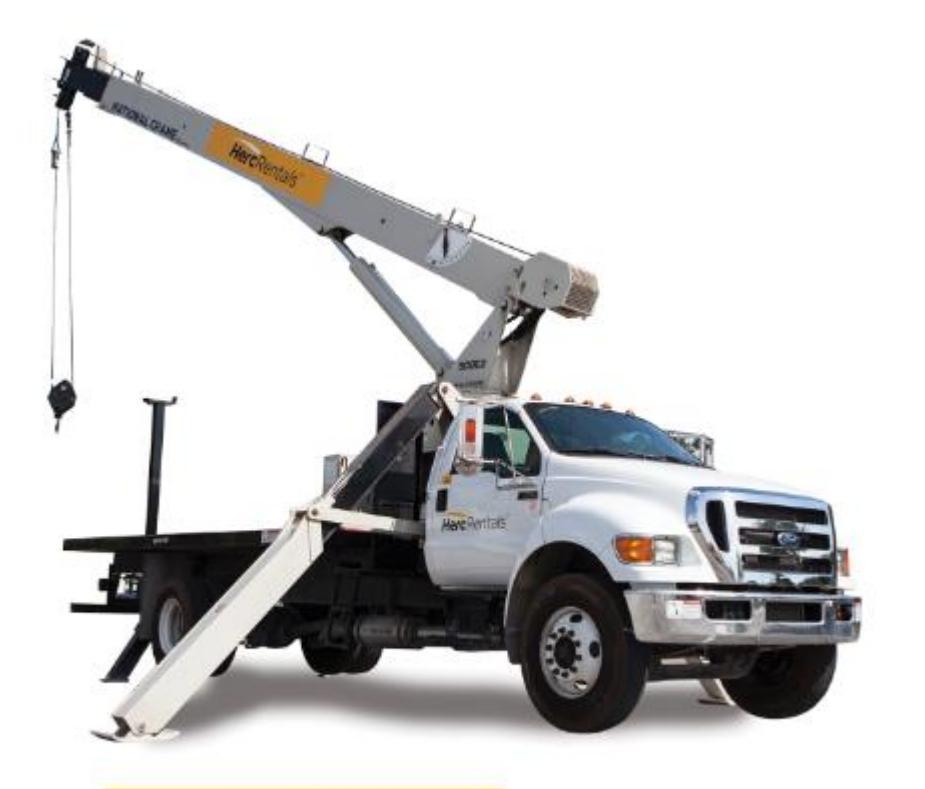
F-750 / 18 Ton

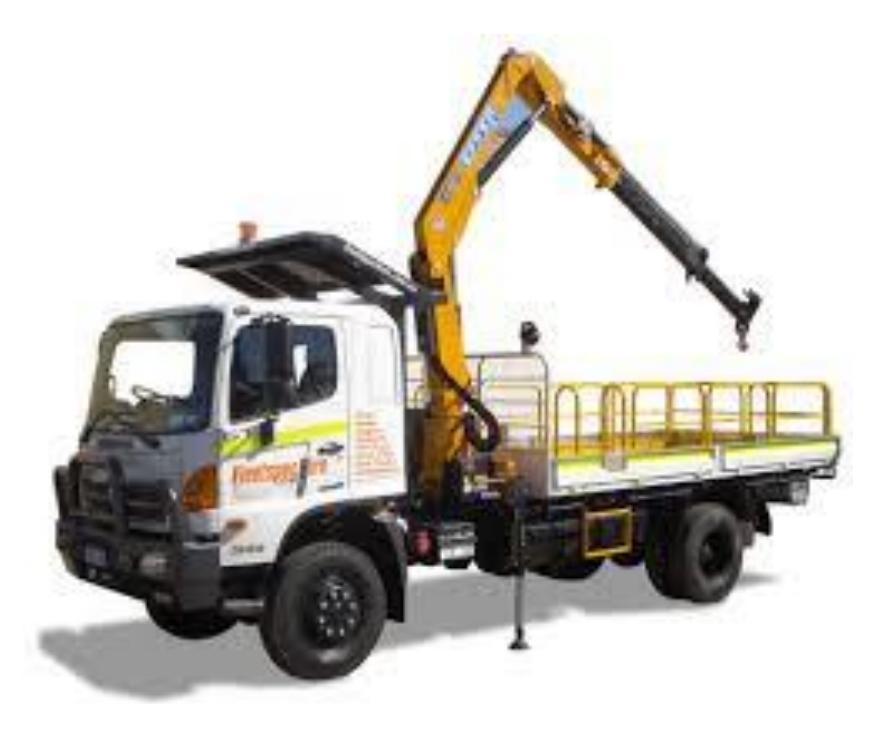
Installation of Plywood enclosure:

- Crane
- 6 laborers
- 4 days, not including washing/maintenance on fountain stems/arms
- Approx 253 stems
- Stems are stored in basement of Community Center
- Plywood frames stored off-site

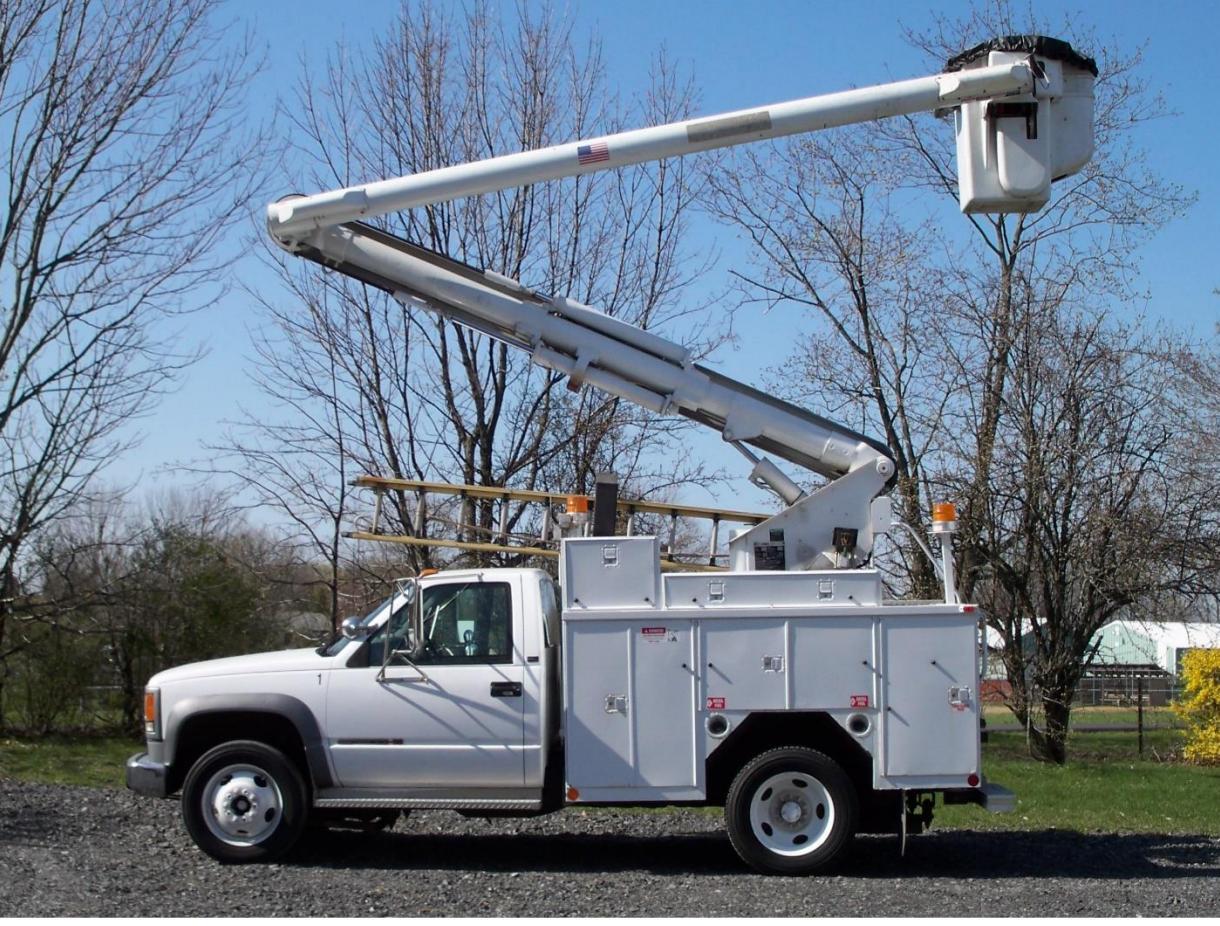
Bucket trucks owned by Minneapolis Park & Recreation Board.

Used for tree management and street/path lighting repair and lamp replacement
